LLL: UCRL-52533 NASA: CR-159512

HIGH-PERFORMANCE FIBER/ EPOXY COMPOSITE PRESSURE VESSELS

T. T. Chiao, M. A. Hamstad, E. S. Jessop, and R. H. Toland

December 12, 1978

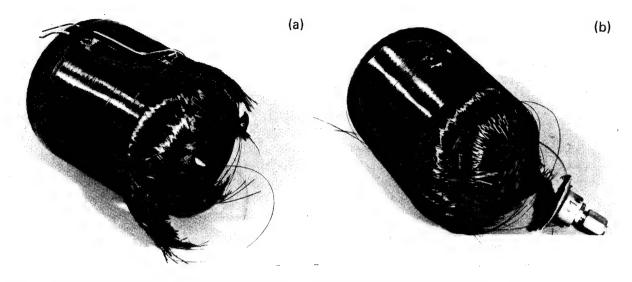
After these tests were completed, the vessels were cut in half for inspection. All of the cracks that led to the fatigue failures occurred in the center welds. Examination of the liner-to-composite adhesive bond indicated that this bond had retained its integrity during the cyclic testing of both the aluminum-lined and the titanium-lined vessels.

Fig. 12. Photograph of typical end failures during burst tests of titanium-lined (left) and aluminum-lined (right), Thornel Special graphite fiber/epoxy pressure vessels.

As is indicated in Table 7, this performance factor could be increased about 8% by replacing one boss with a dummy boss. A further increase in performance could be gained by improving our filament winding pattern to produce a balanced vessel (i.e., one with random failure locations). The current winding pattern, fixed after testing only one vessel, forced the burst failure to the fitting region (Fig. 12). In addition, some further gains in vessel performance may be possible with a better liner design. The limit to such improvements is somewhere below the composite performance factor given in Table 3 for an all-composite vessel (0.351 MPa·m³/kg).

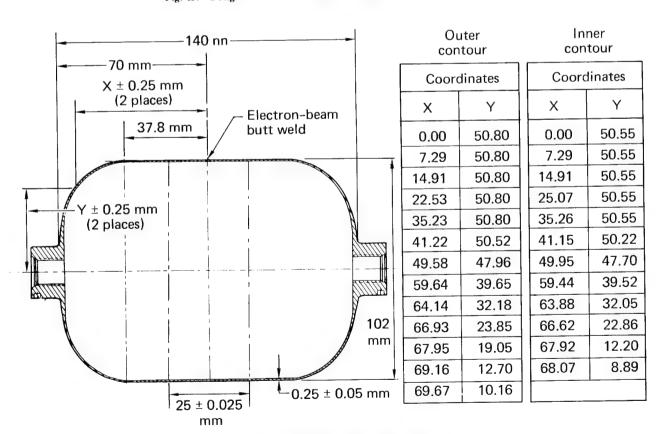
Fig. 14. Redesigned titanium alloy liner.

ure, or sinusoidally cycled at a rate of 0.66 Hz between 0+ and 50% of their expected burst pressure. After three of the first four vessels tested failed by leakage and could not be burst, we examined the liners and discovered that during pressurization, small cracks had developed from a stress concentration located at the transition from the liner thickness to the boss.

The redesigned liner (used in the third set of vessels) successfully solved the problem of the stress concentration at the ends of the titanium liners. Thus, it was no longer necessary to coat the inner ends of these vessels with epoxy. The redesigned liner was slightly heavier, however, resulting in an increase in total vessel weight of about 5%. During the fatigue tests of the third set of vessels, all failures resulted from cracks in the welds. Figure 16 plots the cyclic strains during the first fatigue cycle for a typical vessel wound over this redesigned liner.

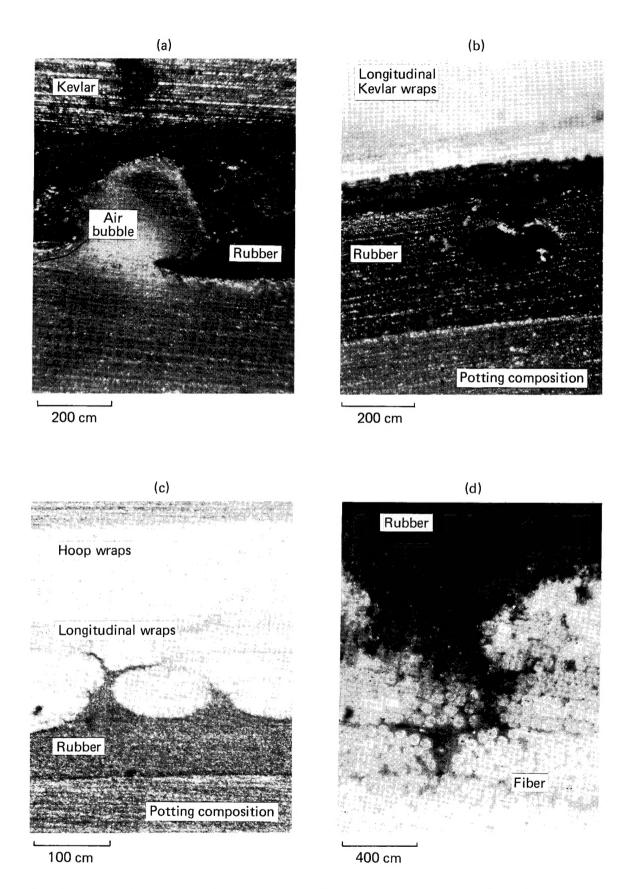
Fig. 43. Photomicrographs of four wall sections illustrating some of the problems with the liners: (a, b) 20.3-cm³-diameter vessels with voids, (c, d) 10.2-cm-diameter vessels with rubber migration.
